MODEL 243 Shielded Well
CRYSTAL REMOVAL AND
REPLACEMENT

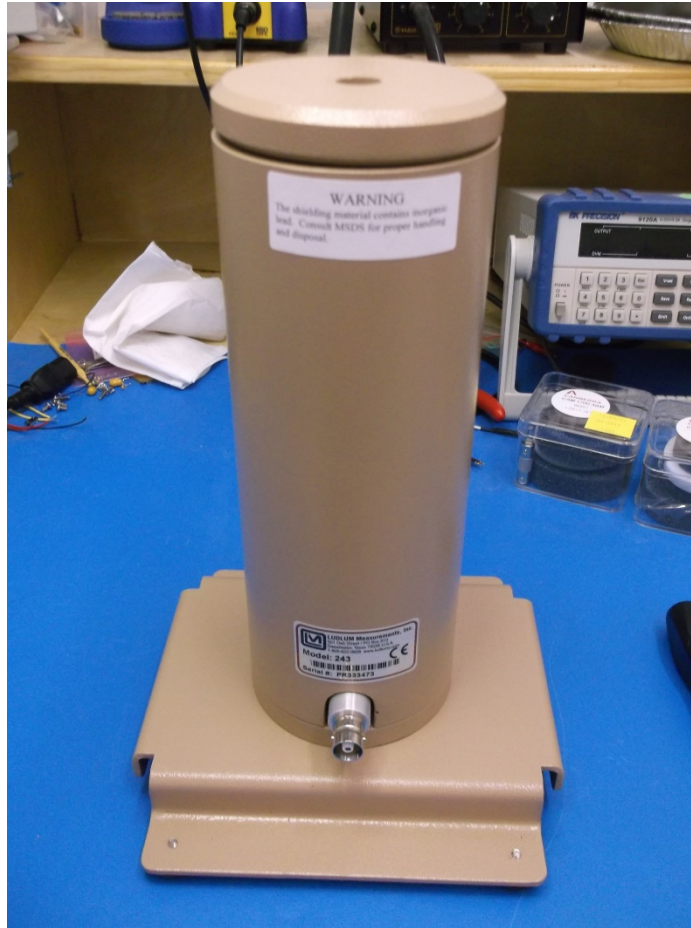
FULLY ASSEMBLED MODEL 243

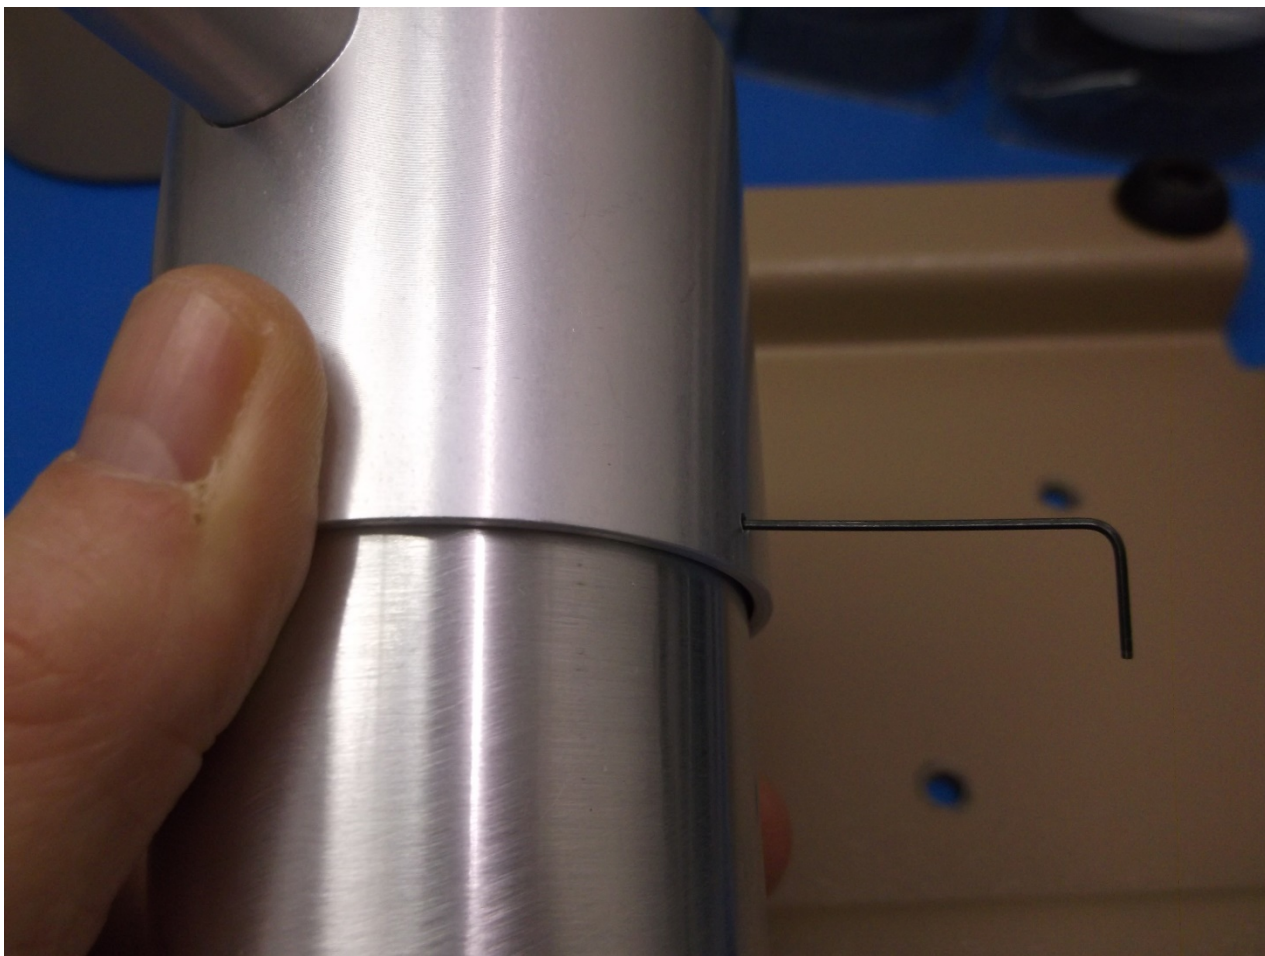
Loosen the Allen screws on the detector socket.

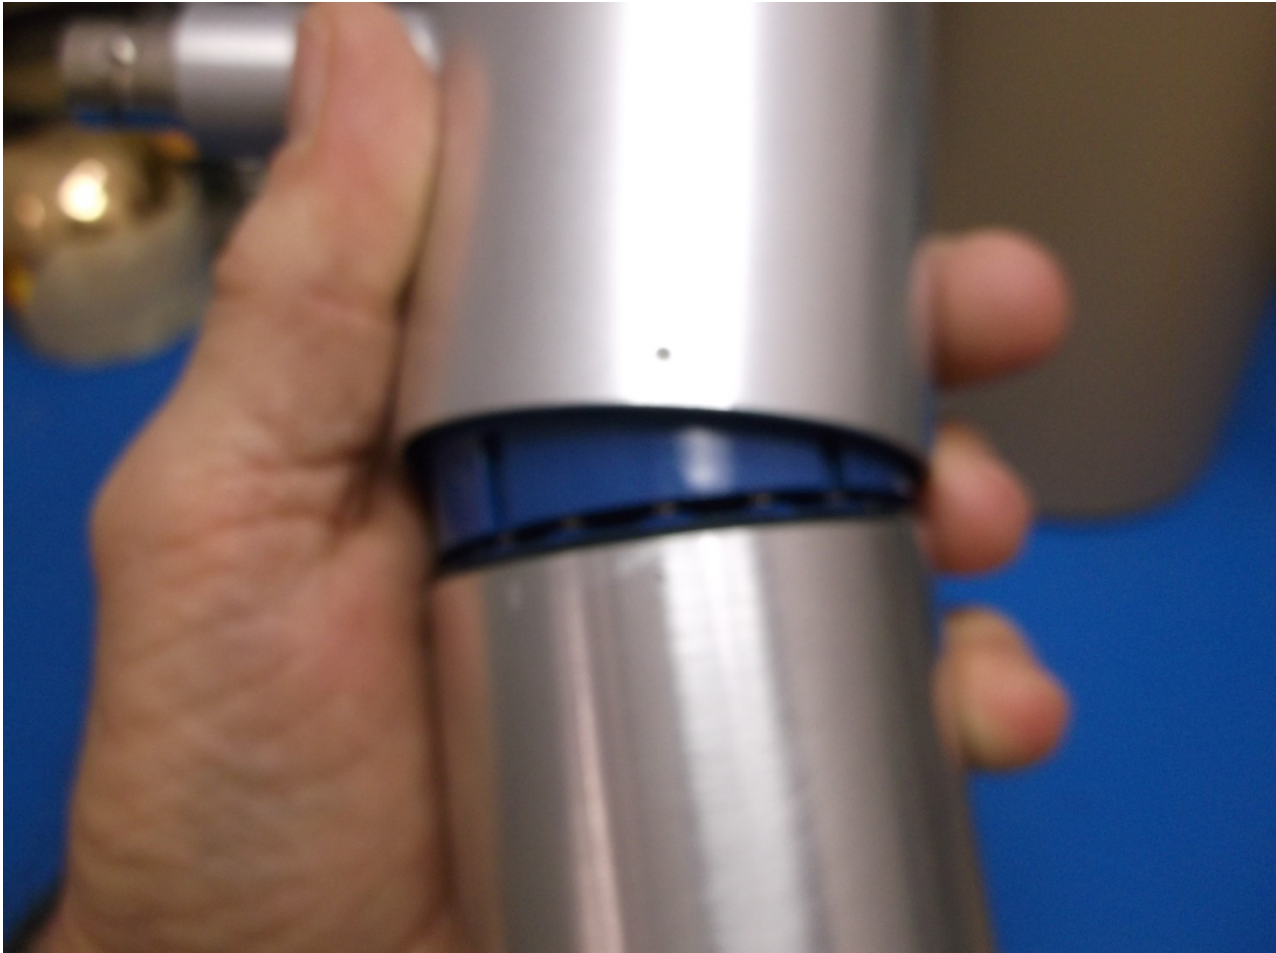
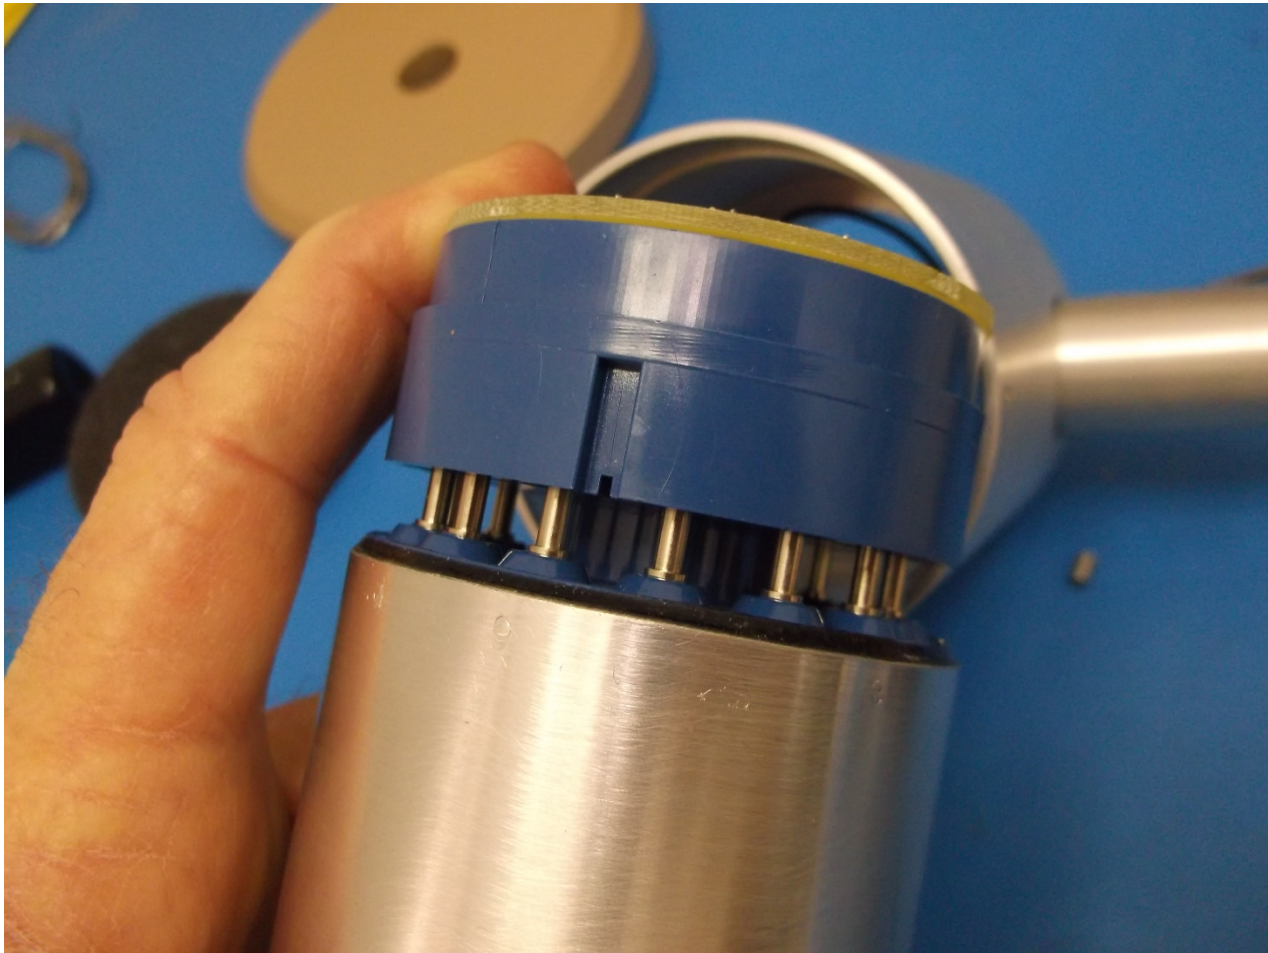
Pull the socket loose from the defective PMT. Reattach to new PMT.

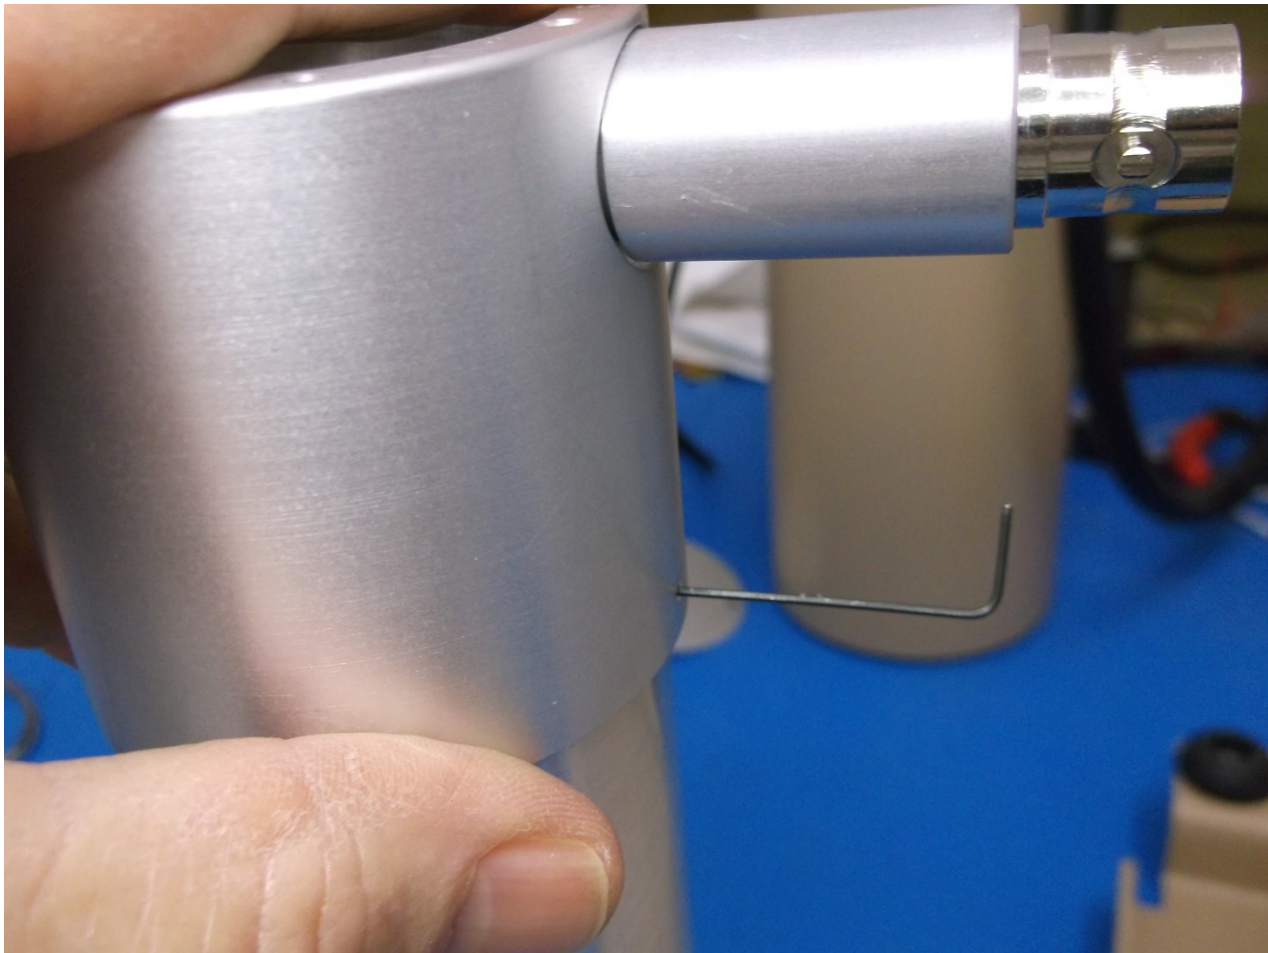
Reattach the socket body and tighten the Allen screws.

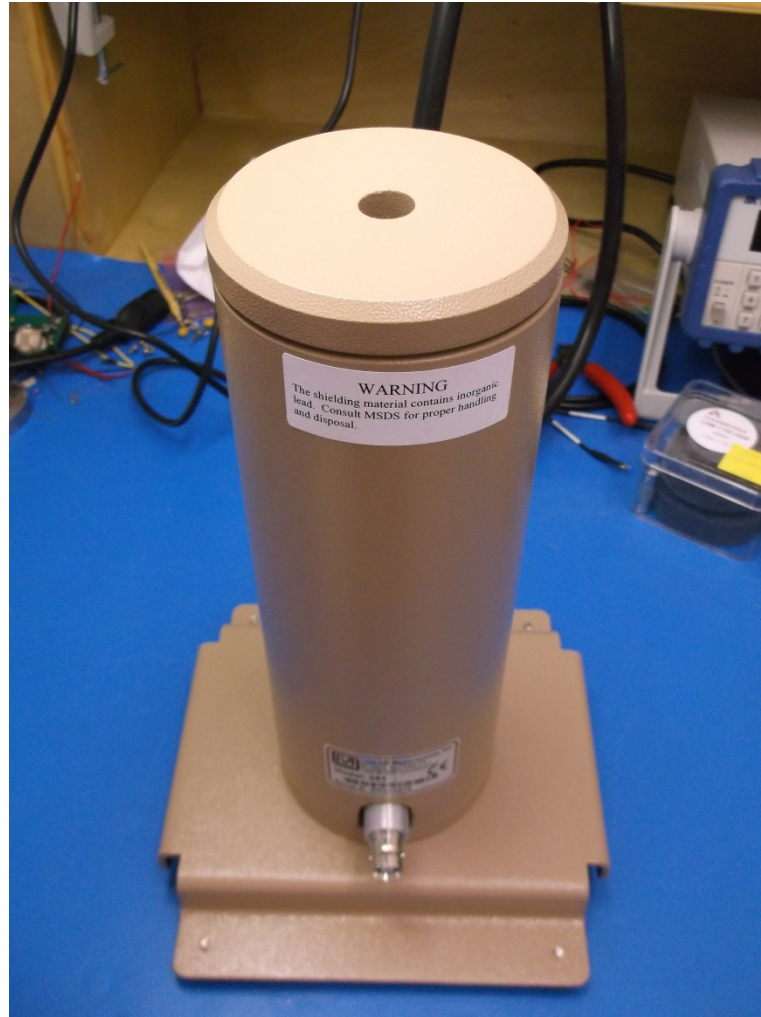
Fully Reassembled Model 243.
